ESSAY

Mandibular Fractures: Pre-Operative Panoramic Radiography and Duplication Sign Patterns

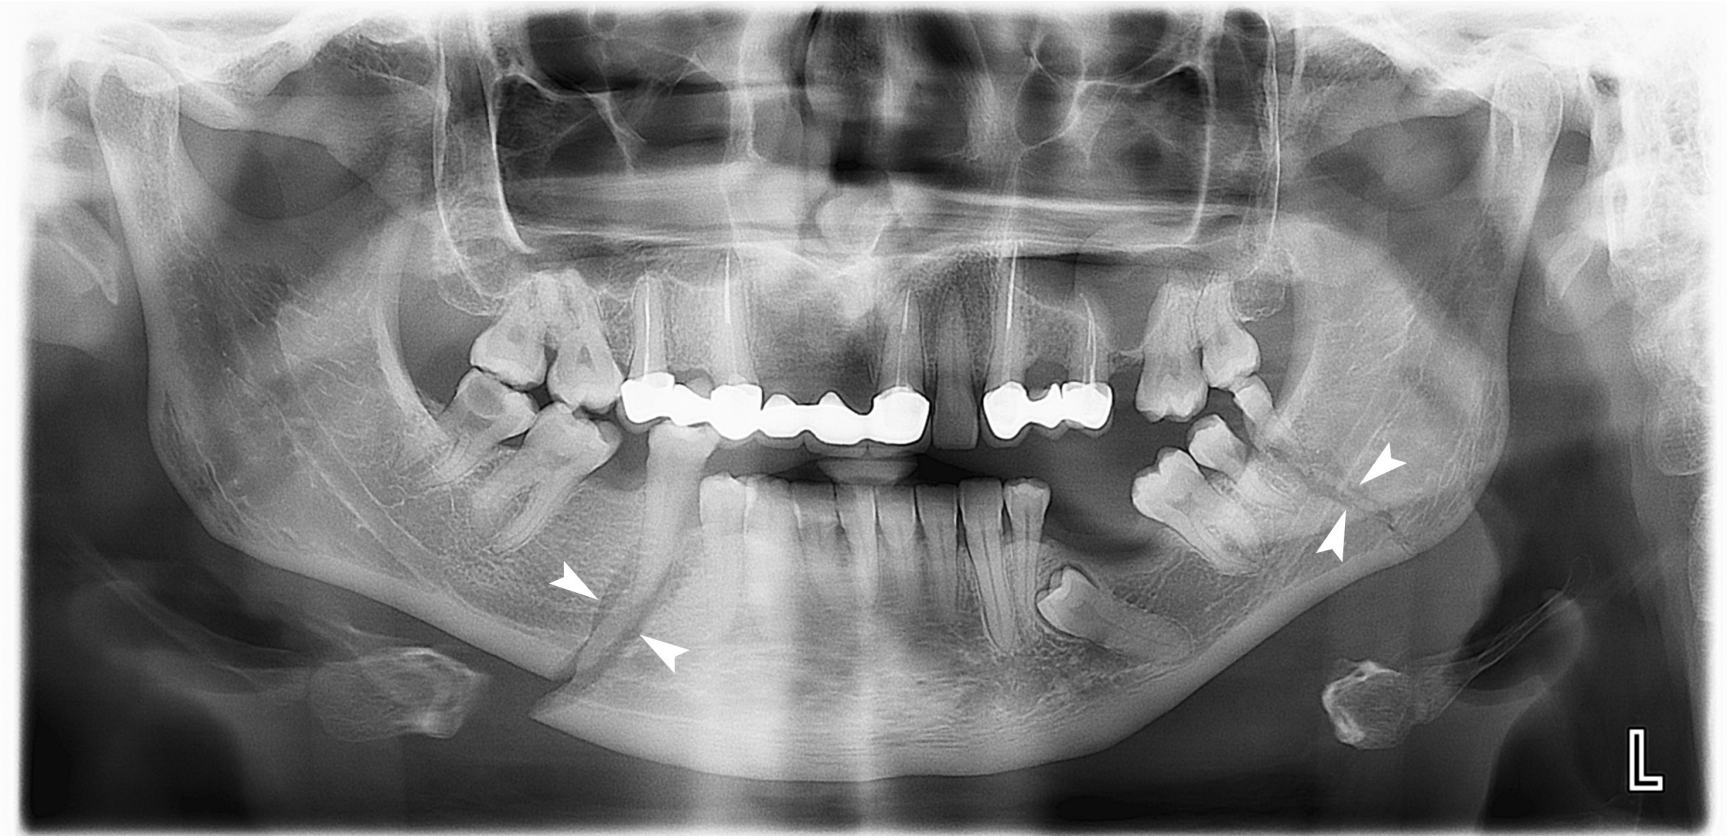
FIGURE 1. Case 1: A 34-year-old patient with bilateral mandibular fracture with duplication sign (*arrowheads*) at each fracture site.

Nine patients of the age varied from 23 to 45 years old with duplication sign at mandibular fractures on PR images were analyzed (Figs 1–9). In seven of nine fracture cases (ie, in 77.77 percent) the bilateral mandibular fracture was established. In three of nine patients (ie, in 33.33 percent) the bilateral mandibular fractures with duplication sign at each fracture site were noted. So, totally 12 patterns of duplication sign were investigated.

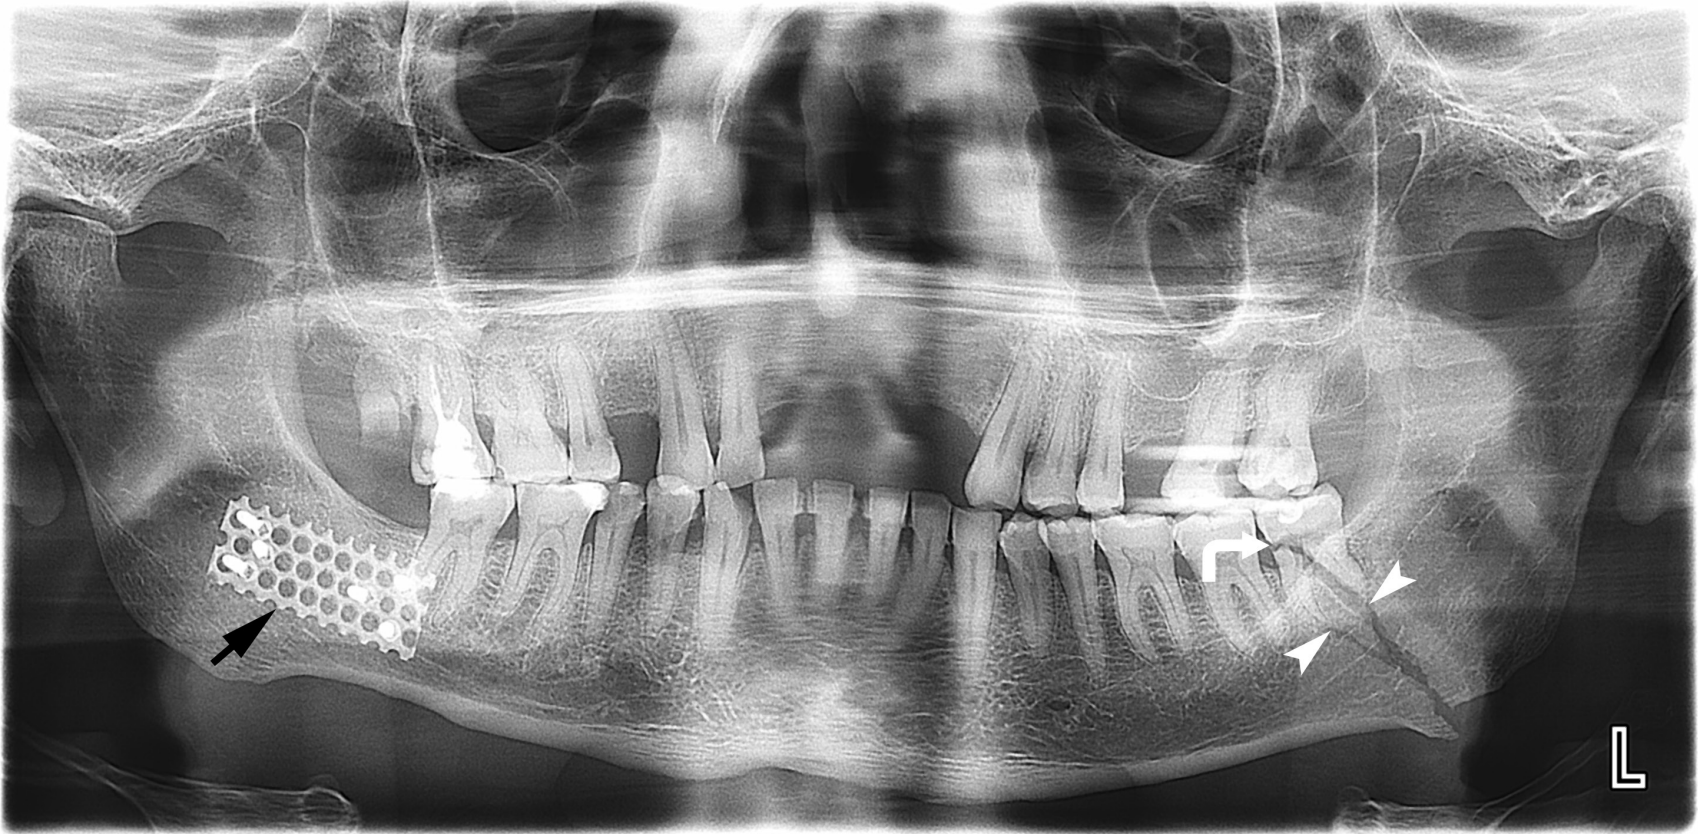
FIGURE 2. Case 2. A 39-year-old patient with mandibular fracture at the left angle with duplication sign (*arrowheads*) at the fracture gap. *Curved arrow* indicated on the fractured lower left third molar. Osteosynthesis plate (*arrow*) in the area of consolidated fracture visualized at the right hemimandible.

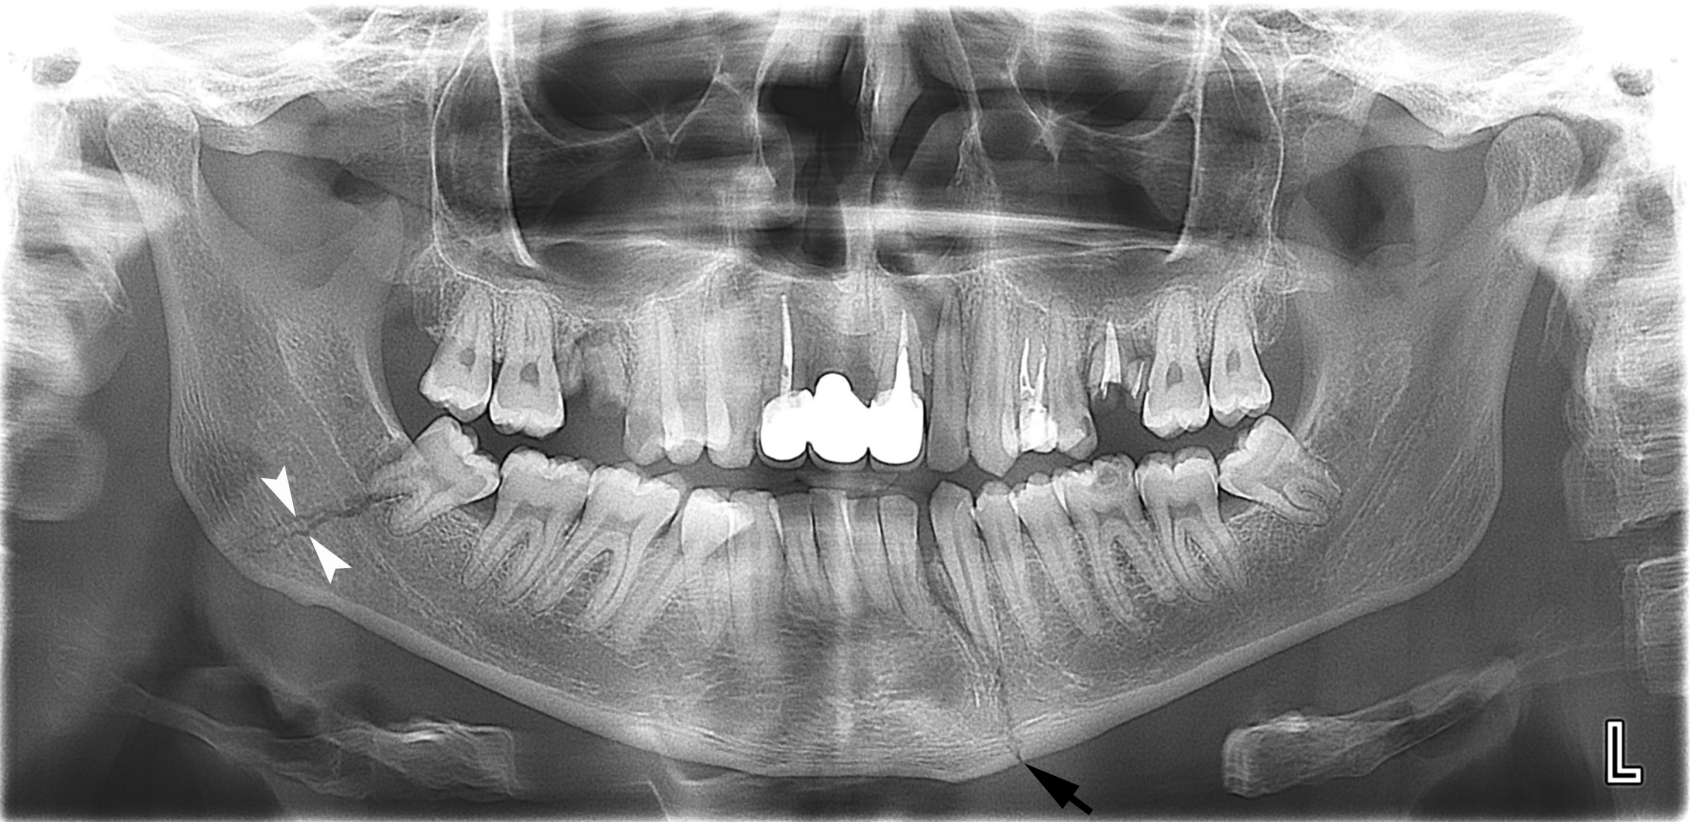
FIGURE 3. Case 3: A 23-year-old patient with bilateral mandibular fracture – at the right angle area with duplication sign (*arrowheads*) and one-line fracture (*arrow*) between tooth 3.2 and 3.3.

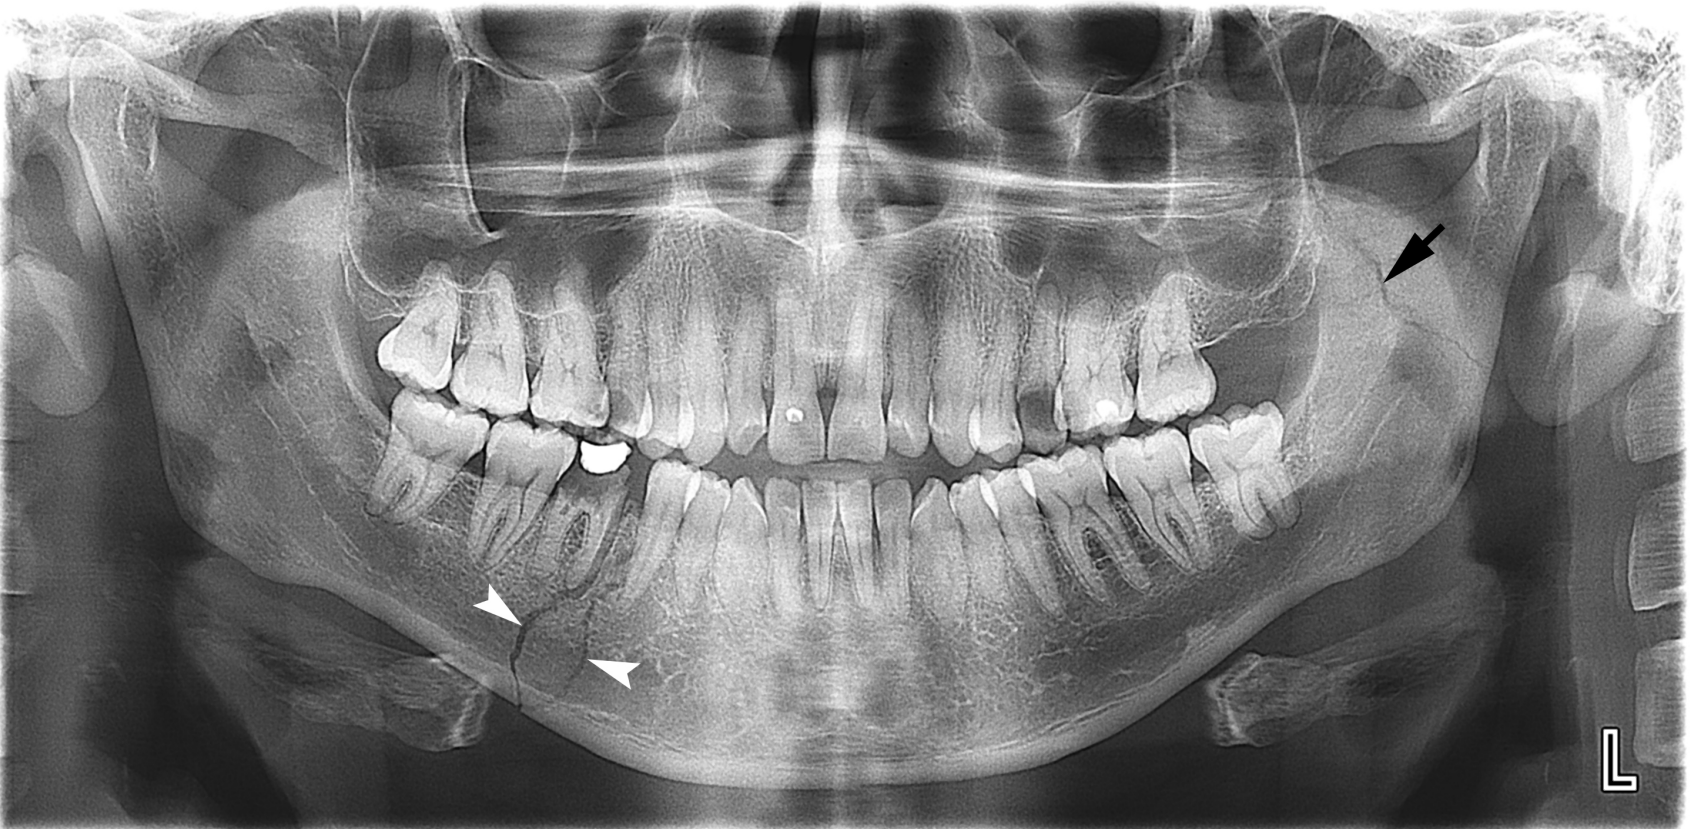
FIGURE 4. Case 4: A 33-year-old patient with bilateral mandibular fracture – at the right body area with duplication sign (*arrowheads*) and one-line fracture (*arrow*) of the left ramus.

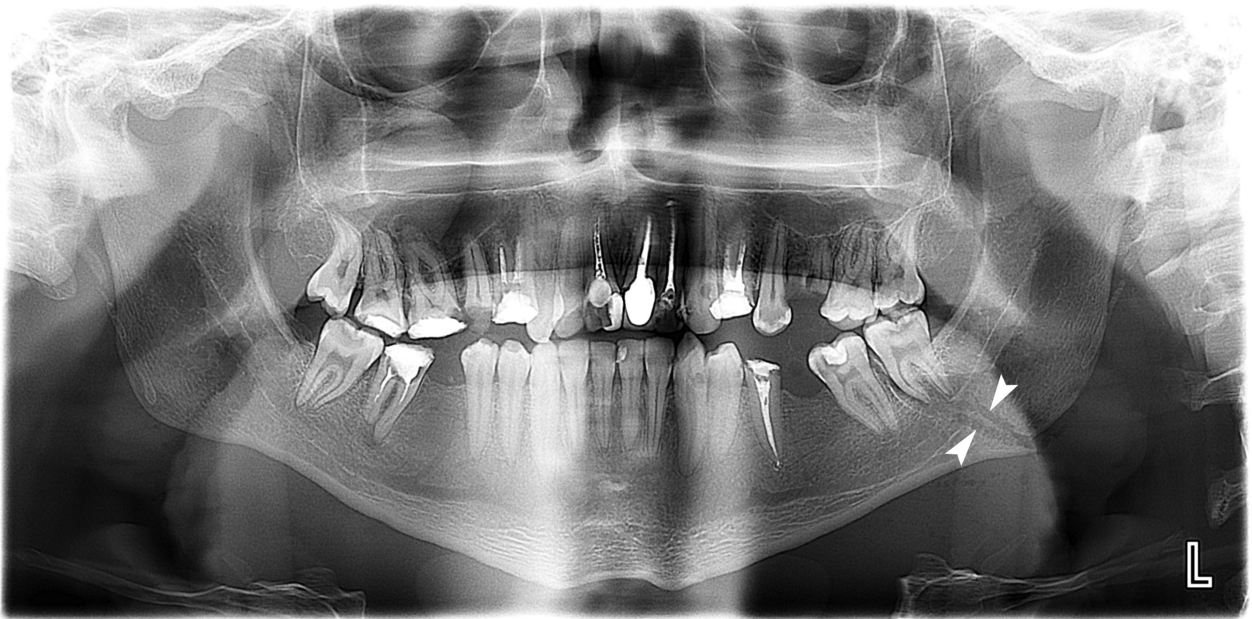
FIGURE 5. Case 5: A 38-year-old patient with unilateral mandibular fracture – at the left angle area with duplication sign (*arrowheads*).

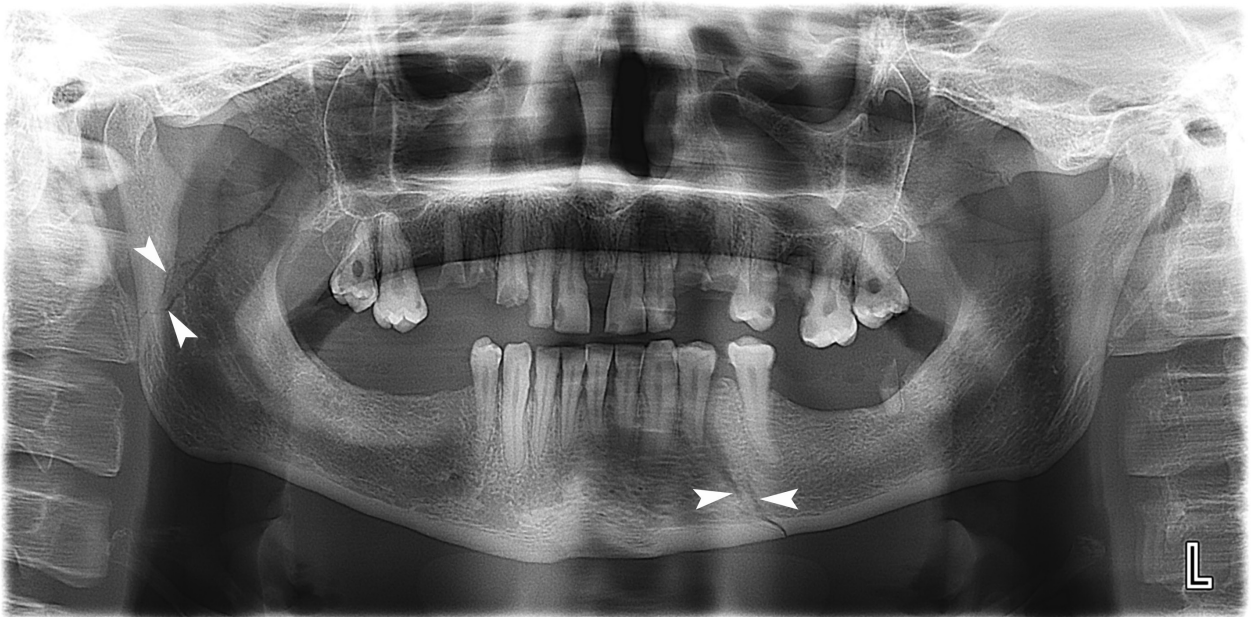
FIGURE 6. Case 6: A 25-year-old patient with bilateral mandibular fracture with duplication sign (*arrowheads*) at the right subcondylar fracture and at the left body area.

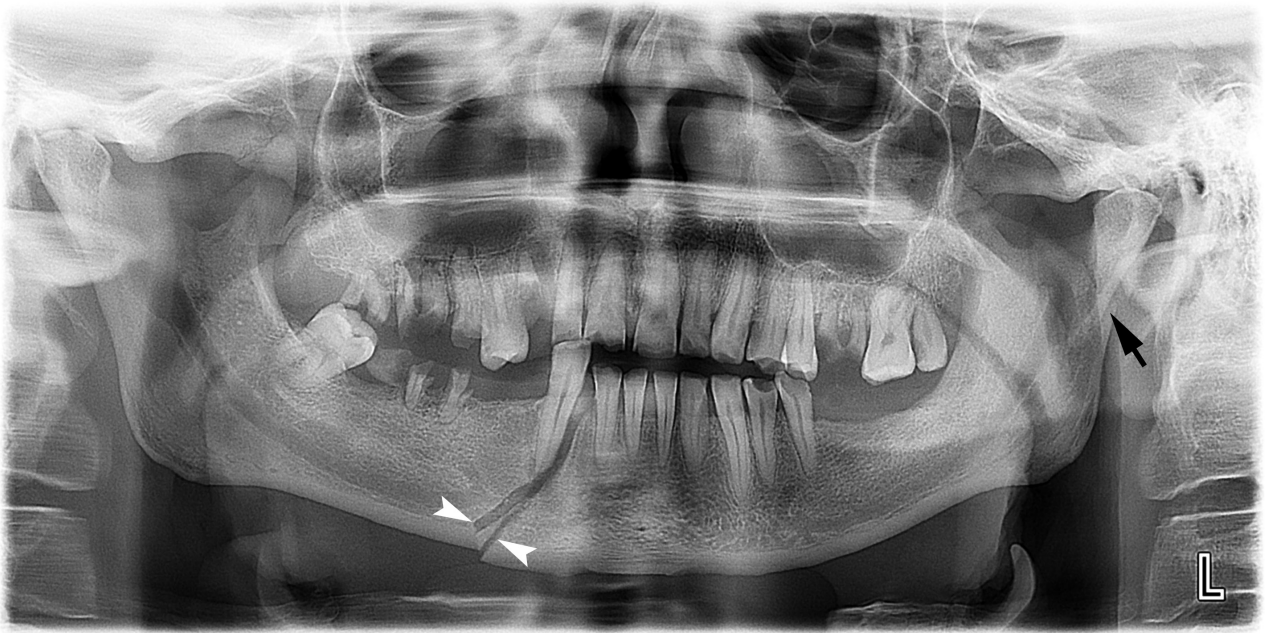
FIGURE 7. Case 7: A 43-year-old patient with bilateral mandibular fracture – at the right body area with duplication sign (*arrowheads*) and subcondylar fracture (*arrow*) with shadows' superposition sign.

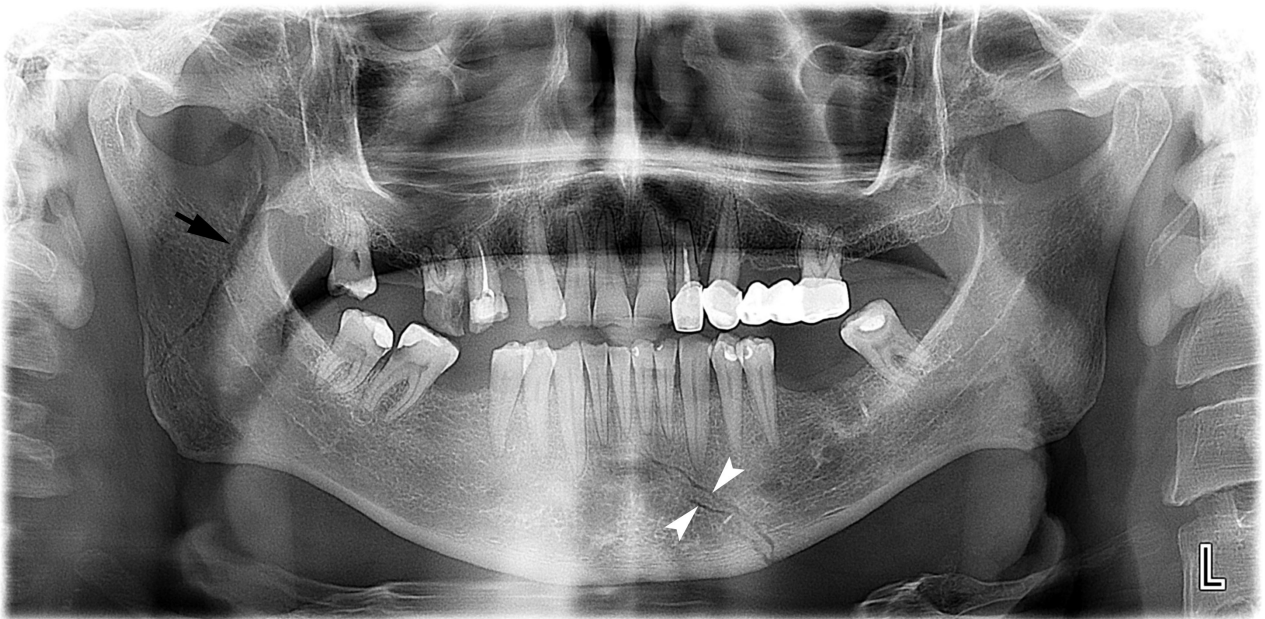
FIGURE 8. Case 8: A 45-year-old patient with bilateral mandibular fracture. The fracture area with duplication sign is indicated by *arrowheads* and one-line fracture – by *arrow*.

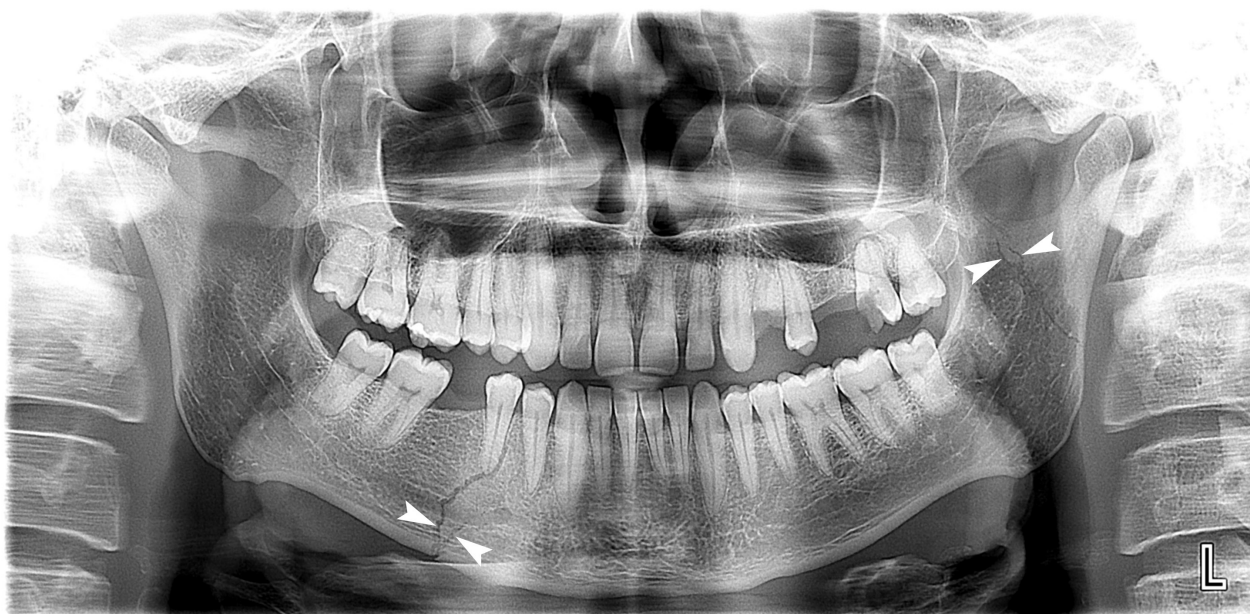
FIGURE 9. Case 9: A 36-year-old patient with bilateral mandibular fracture with duplication signs (arrowheads).
